# TRINITY-BY-THE-COVE EPISCOPAL CHURCH STORM RESILIENCE COMMITTEE

## **FINAL REPORT**

April 2025

Naples, Florida

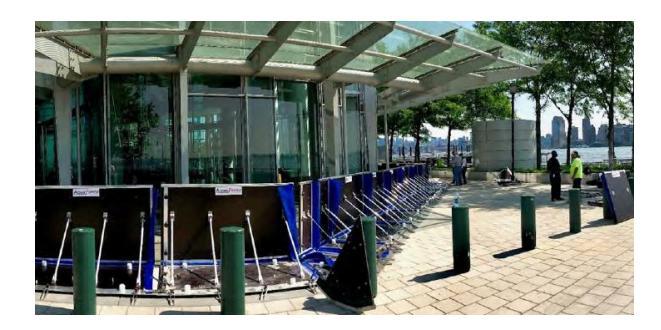
Figure 3--AquaFence

**Temporary Perimeter Barrier (AquaFence).** Several parishioners drew the committee's attention to the successful use of AquaFence (www.Aquafence.com) at the Tampa General Hospital during the storms of 2024. The committee gave serious consideration to this product. Its advantages are that, installed properly, it serves as an effective barrier to flood water. Committee members met with AquaFence representatives onsite and fully explored its capabilities and limitations. AquaFence staff provided a detailed proposal for the church site. The AquaFence would encircle all the site structures as well as the east and west churchyards. The cost, including twin buried concrete footings to secure the fence would be approximately \$600,000. AquaFence has some limitations. It requires a trained crew to install. It must be properly stored offsite, it is unattractive when erected. Moreover, it is subject to damage and potential failure from trees or limbs. None of these limitations were deemed to be "Fatal flaws" and the committee considered AquaFence as a viable solution to the problem.

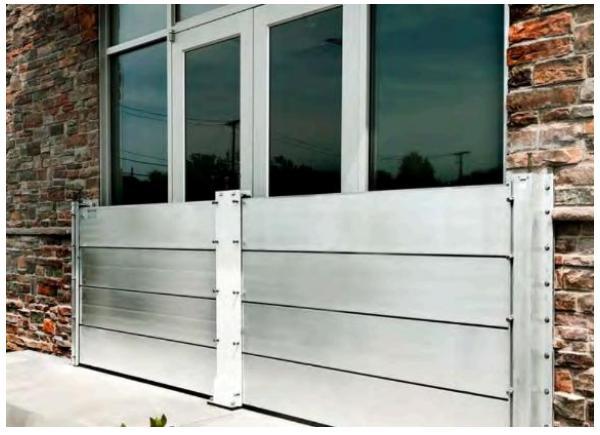
Figure 4- Removable Flood Logs

**Flood Logs<sup>2</sup> and Panels at Doors.** There are many types of flood panels on the market. We were drawn to the product line of Floodproofing.com since one of the committee members had realized successful results from this organization. Committee members met twice with representatives of Floodproofing.com to discuss our application. This resulted in a proposal covering the entire campus. The proposal was approximately \$100,000, however with supplemental items, such as structural engineering evaluations and a few additions, the total cost is estimated to be approximately \$150,000. The proposal covers 16 doorways, so for just the church with five doorways, the cost would be approximately \$50,000.

<sup>&</sup>lt;sup>2</sup> Flood logs are aluminum planks measuring about 12 inches by 1 inch in section and of a length to cover a doorway that is susceptible to flooding. Some 3 to 5 "Logs" are inserted into a pair of vertical channels that are secured to the building. Properly gasketed, the assembly forms a seal with the building and blocks the entrance of flood water.

Flood logs are a cost-effective solution, and the performance of this product has been good. There is some preparation work before a hurricane, but not as extensive as with the AquaFence. Storage requirements would be a fraction of those required for Aquafence. An unknown is whether this solution would fully satisfy our goal of preventing water intrusion

since the flood waters would be directly against the exterior church walls. A key unanswered question--would hydrostatic pressure against the exterior walls result in seepage under the structure and up into the interior from cracks or seams in the church's floor slab? Given the short duration of storm surges, we suspect that this would not be a problem, but we are not sure. If budget were severely constrained, the committee thought this would be a potentially acceptable solution.

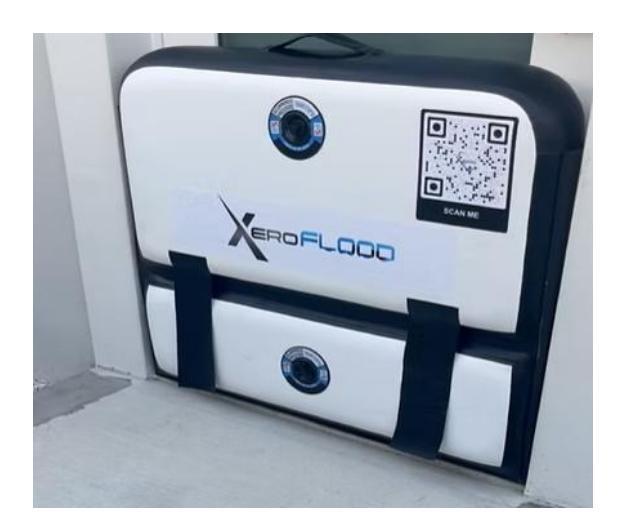
Figure 5—Xero Flood Barrier

**Xero Flood Barriers at Doors.** Xero Flood (Xeroflood.com) is a double-chambered bladder, custom fit to each door and window opening. The bladders are filled with air with pressure between 10 and 15 psi. Because they are custom fit to each opening, they fit snugly when uninflated. When inflated by a portable air pump, they expand laterally and become impossible to dislodge. The air provides rigidity, so the barrier is tight, rugged and waterproof. The barrier locks into place in the framed recess of the door. Most often, the recess is on the outside, such as in the illustration below, but sometimes it is on the inside. The recess must be structurally sound to resist the lateral force of the barrier. Any exterior cracks in adjoining sidewalks are sealed to prevent water intrusion under the barrier.

Xero Flood barriers are a relatively new product. They were recently subjected to full-scale testing by the National Research Council of Canada along with other types of flood barriers. They were effective at preventing leakage into the sample building. The only possible drawback is that the standard barrier, shown above, is limited to an effective height of 31.5 inches. This means that floods with surges higher than elevation 8 feet could overtop the units (lan's surge elevation at the church was approximately 8 feet. Milton's

surge elevation at the church was approximately 7.5 feet.) We have received proposals from Xero Flood that cover the doors in the church and its outbuildings. Based on the proposals the estimated cost to secure all these openings is \$11,000.

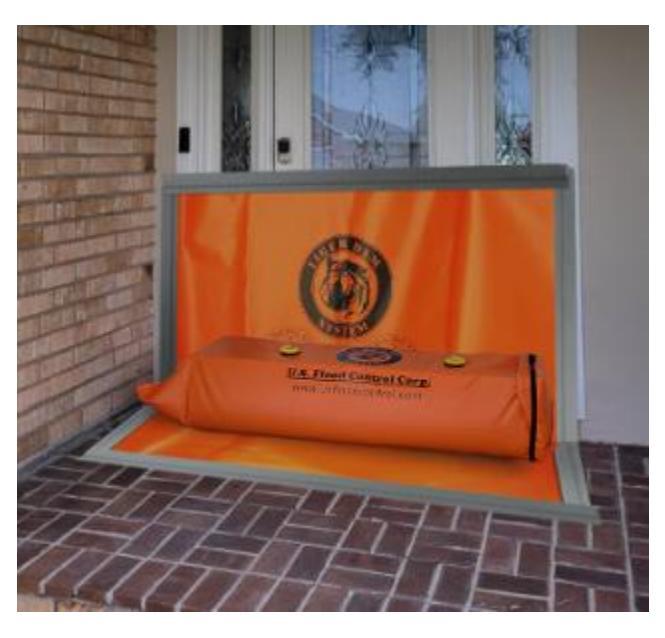
Figure 6--Tiger Dam System

**Tiger Dams at Doors.** Tiger dams are water-filled bladders placed in door openings. They are backed up with a tarp, acting as flashing, that is secured to the opening with waterproof tape. The combination of the inflatable bladder and the tarp have proved to be an effective, low-cost barrier to flood waters.
